SAFETY ALERT

Safety Alert No. 371
December 5, 2019

Conductor Failures Put Workers' Safety and the Environment at Risk

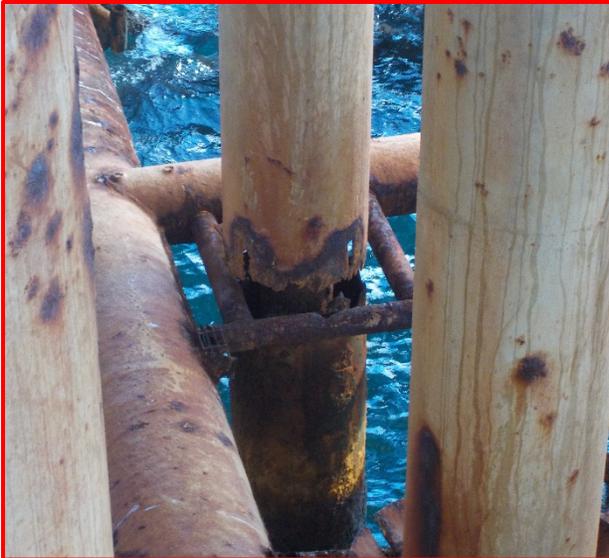
The conductor is severed near the water line, affecting the structural integrity of the well.

- Prevent water and air from entering the conductor-casing annular space, and between the conductor and casing;
- Ensure any supports or clamps that are attached to a conductor do not accumulate water;
- Conductors should be properly supported and maintained for lateral loading. Do not use ropes or chains as a long-term solution to prevent movement;
- Maintain cathodic protection, verify that anodes are actively providing protection within performance requirements, and confirm voltage measurements are within acceptable range; and,
- Complete inspection testing on a recurring basis (e.g. ultrasonic/UT, laser, etc.) to determine the extent of metal loss and repair as needed.

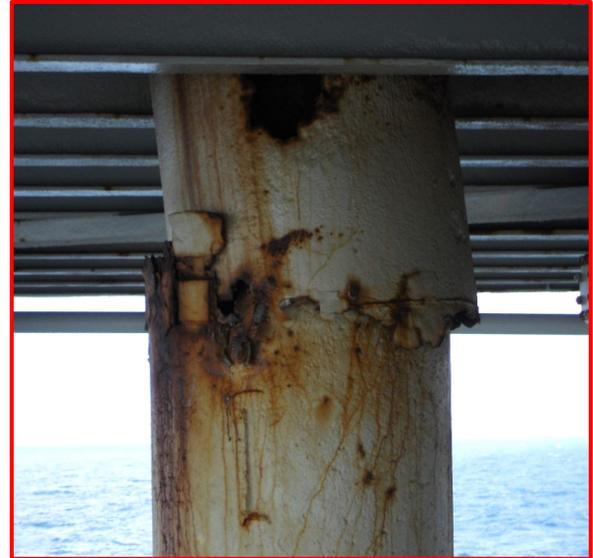
The conductor has a fracture and is leaning to the side, causing stress on the associated equipment.

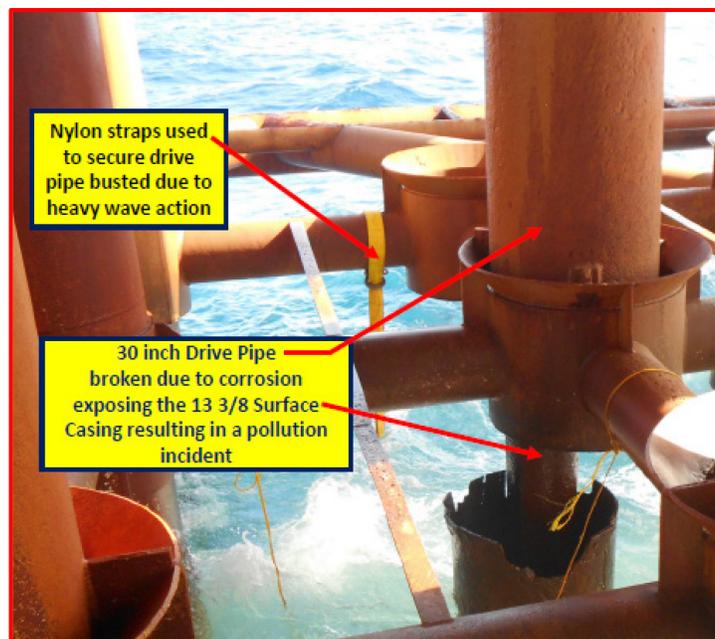
The conductor (Drive Pipe) is parted below the bell guide.

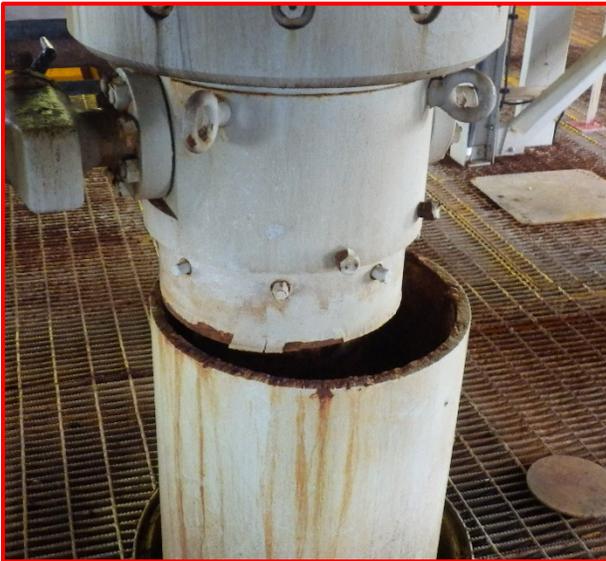
The lack of lateral stabilization and conductor-casing annulus cover may reduce structural support of the conductor.

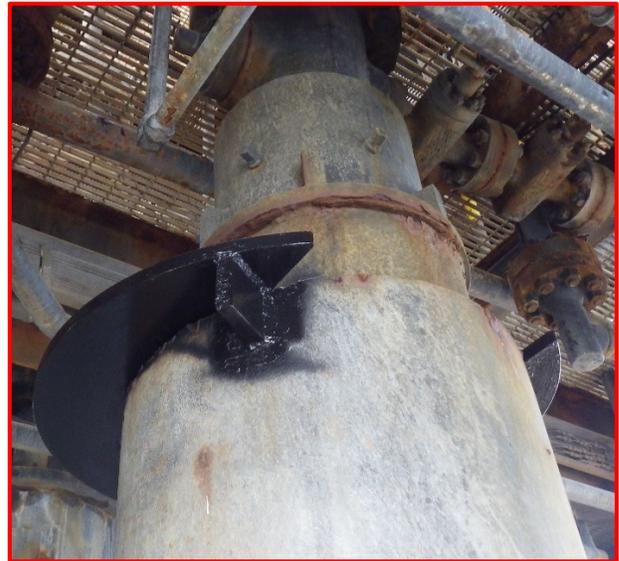
The original support / framing collar at the top of this conductor is missing, exposing the insider. A new collar was welded to the top, but it is not connected to the Wellhead and does not fully cover the opening.
